Chlorine Dioxide Gas Decontamination of Large Animal Hospital Intensive and Neonatal Care Units

Henry S. Luftman¹, Michael A. Regits¹, Paul Lorcheim², Mark A. Czarneski², Thomas Boyle³, Helen Aceto⁴, Barbara Dallap⁴, Donald Munro⁵, and Kym Faylor⁶

¹Micro-Clean, Inc., Bethlehem, Pennsylvania; ²ClorDiSys Solutions, Inc., Lebanon, New Jersey; ³University of Pennsylvania, Philadelphia, Pennsylvania; ⁴University of Pennsylvania School of Veterinary Medicine, New Bolton Center, Kennett Square, Pennsylvania; ⁵University of Pennsylvania School of Veterinary Medicine and Pennsylvania Animal Diagnostic Laboratory System (PADLS), New Bolton Center, Kennett Square, Pennsylvania; and ⁶Microbiological Environments, Bethlehem, Pennsylvania

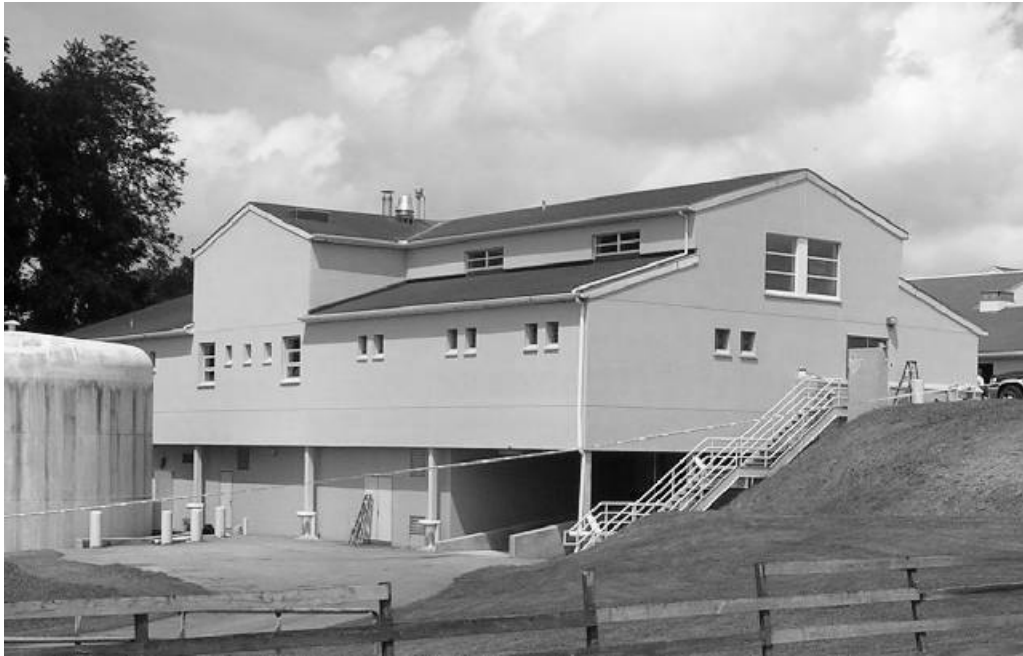
Figure 1

George D. Widener Large Animal Hospital

The ICU/NICU comprises a nearly isolated building, adjoined through one hallway to an equine orthopedic ward (Figure 1). The total volume of space considered for decontamination is approximately 4800 m³ (170,000 ft³). Its main floor is comprised of fifteen patient units with wooden sliding doors and appropriate facilities for providing food and waste disposal. This floor also has two nursing stations, a laboratory, a pharmacy, three restrooms, several offices and other smaller rooms. Two weighing stations were built into the floor and an overhead hoist system is present to facilitate the movement of patients and equipment. A second floor contains additional offices, a restroom, kitchenette, and a mechanical room housing the exhaust and supply blowers. Two basement rooms house additional mechanical and storage space, and two elevators and an internal stairway adjoin the floors. Although much of the space had been disinfected, office rooms remained furnished and contained files, as well as other personal effects. Interstitial spaces were visibly soiled. The interstitial space above the basement is open to the earth foundation under part of the building. The HVAC (heating, ventilation and air conditioning) system is 100% in/out. Most of the offices have window air conditioners.

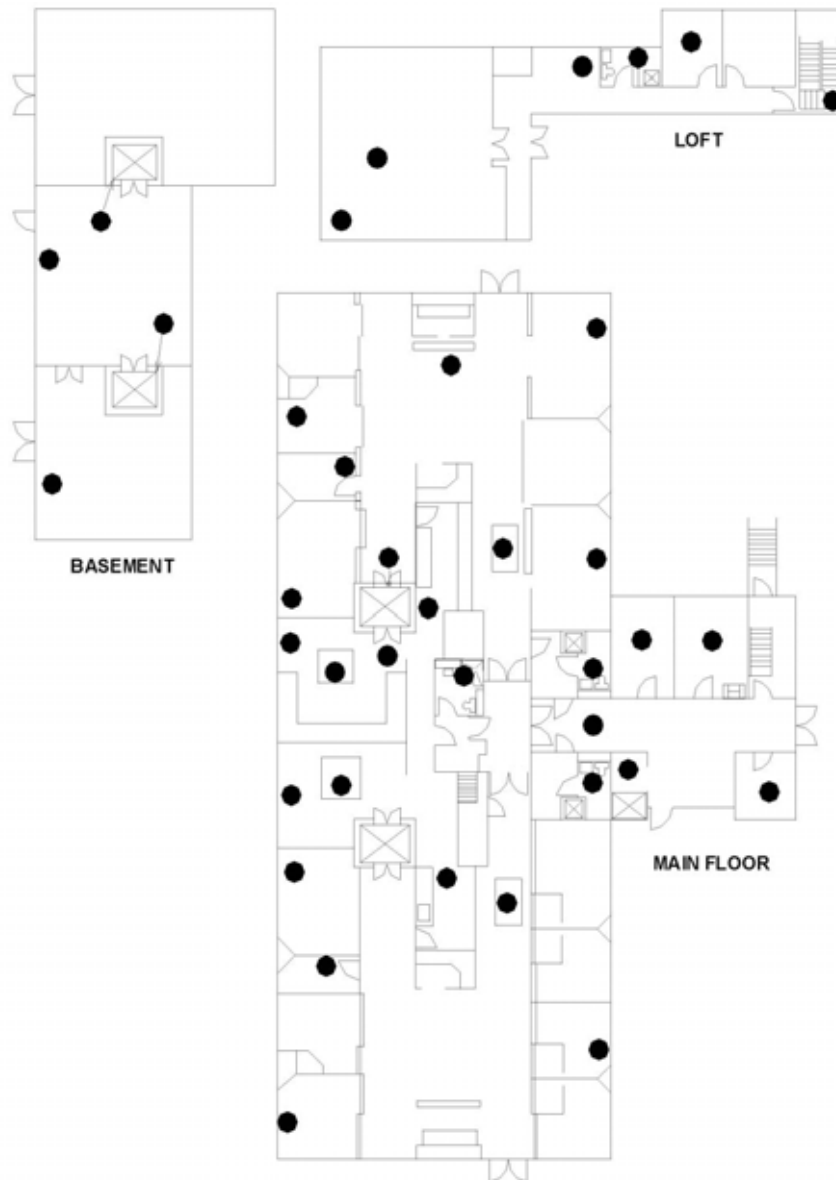
Figure 2

Biological indicator placements. One *Geobacillus stearothermophilus* endospore and one *Salmonella* Newport test strip were placed at each location (•). One *Bacillus atrophaeus* endospore strip was placed at half of these locations (not indicated).

Biological indicators were aseptically placed a few hours before the decontamination throughout the building, including within ceiling interstitial spaces and the HVAC exhaust, to corroborate the efficacy of the decontamination (Figure 2). The indicators included (a) 40 unwrapped strips each with approximately 2×10^6 spores of *G. stearothermophilus* (Spordex), which are considered to be the most difficult challenge for ClO₂ decontamination (Leighton et al., 2004); (b) 20 unwrapped spore strips of *B. atrophaeus* (Spordex), previously known as *Bacillus subtilis var. niger*; and (c) 40 strips inoculated with approximately 10^9 colony forming units (CFU) of the bacterium *Salmonella* Newport. [The *S. Newport* test strips were prepared by the PADLS *Salmonella* Reference Center (SRC). They consisted of 1 x 1.5 inch absorbent paper with an impermeable plastic backing (Benchkote™), inoculated with 1 ml of a 10^9 ml⁻¹ suspension of the bacteria. The strain of *Salmonella* had previously been isolated from an environmental sample submitted to the PADLS laborato-
